**Subject:** PHASE I ENVIRONMENTAL SITE ASSESSMENT  
415, 419, 425, 429 & 501 EAST PUGET AVENUE  
APN's: 160-49-005, 160-49-004, 160-49-006B, 160-49-003,  
160-49-002A, 160-49-001, & 160-49-112C  
AAI DATE: AUGUST 24, 2009

**Project Number: ND30040036 (EAS # 5729)  
AAI Start Date: August 24, 2009**

**Phase I Environmental Site Assessment**  
 415, 419, 425, 429, and 501 East Puget Avenue  
 APNs: 160-49-005, 160-49-004, 160-49-006B, 160-49-003,  
 160-49-002A, 160-49-001, and 160-49-112C  
 Phoenix, Arizona

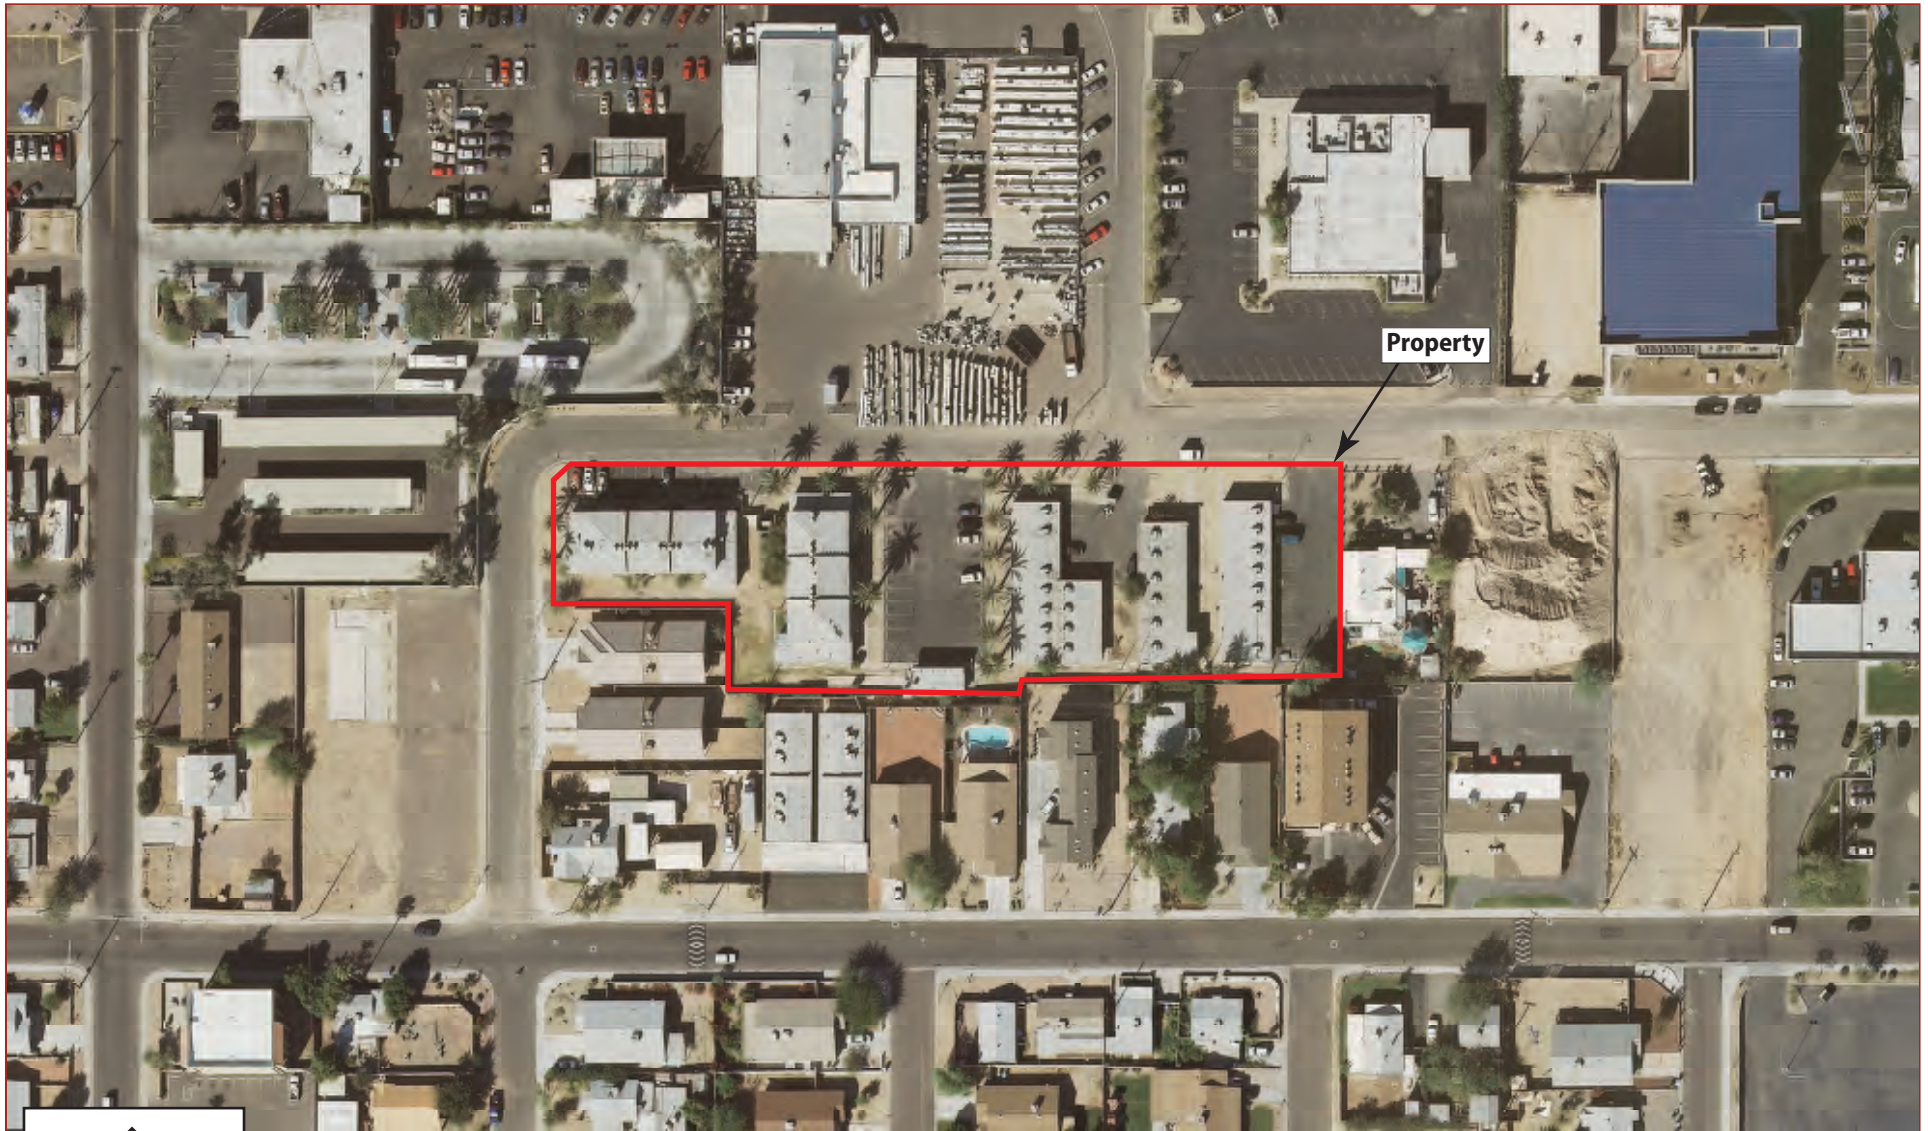
**Figure 3**  
2008 Aerial Photograph

possible USTs or dispensers on the Property). Available aerial photographs are presented in Appendix D, and the 2008 aerial photograph is presented as Figure 3.

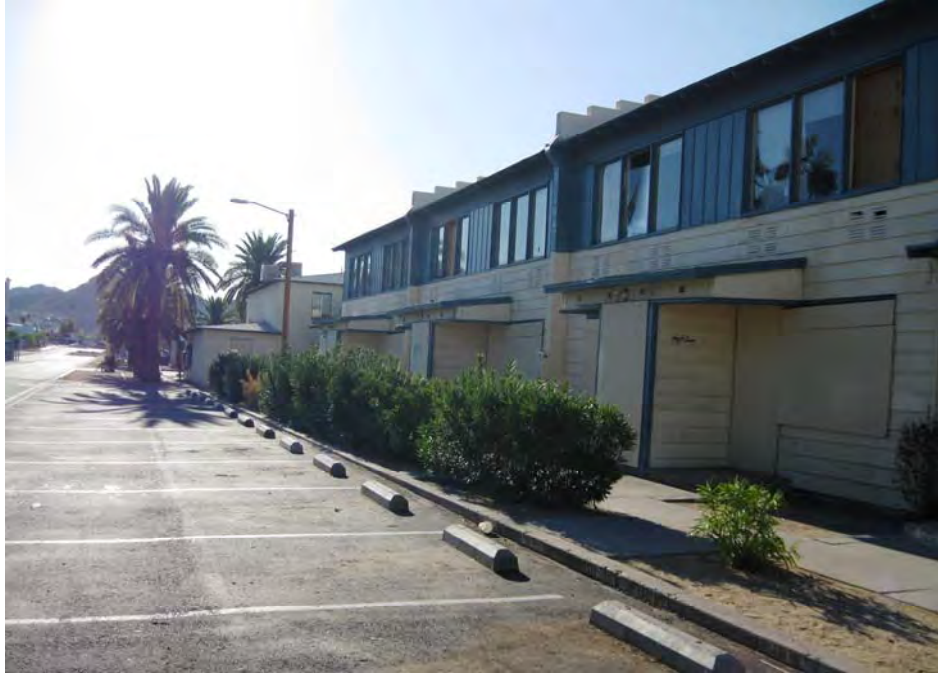
**Description:** View of north side of the Property from the corner of Puget Avenue and Arthur Drive.

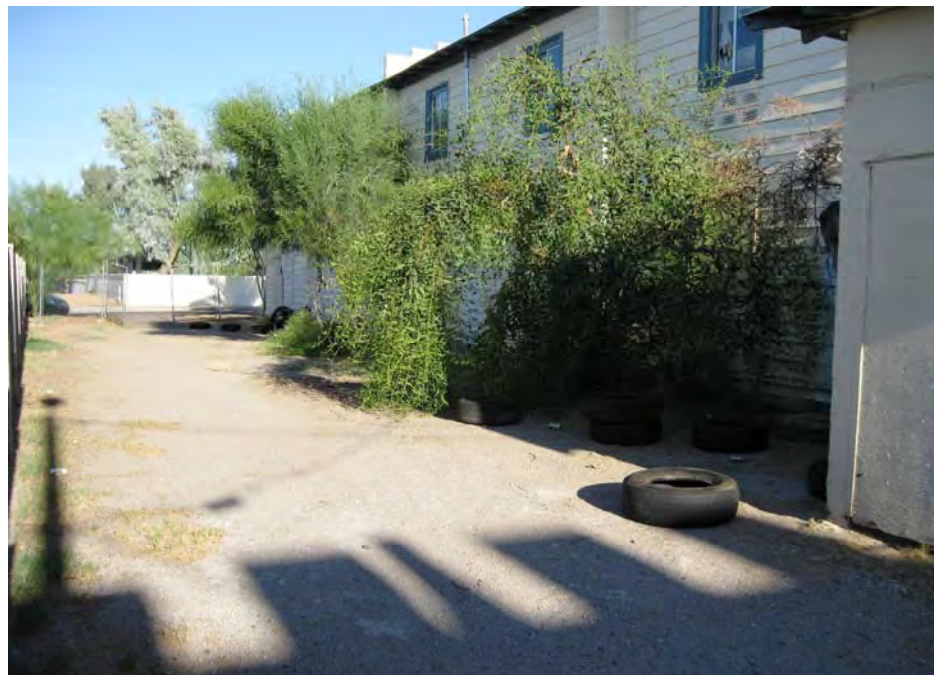
Photograph No. 2

**Description:** View of the tires located on the south side of the western most apartment building.

- Surface staining on asphalt due to leaking parked cars,
- Minor staining on asphalt next to trash dumpster,
- Numerous tires adjacent to building, and
- Scattered trash south of the building.

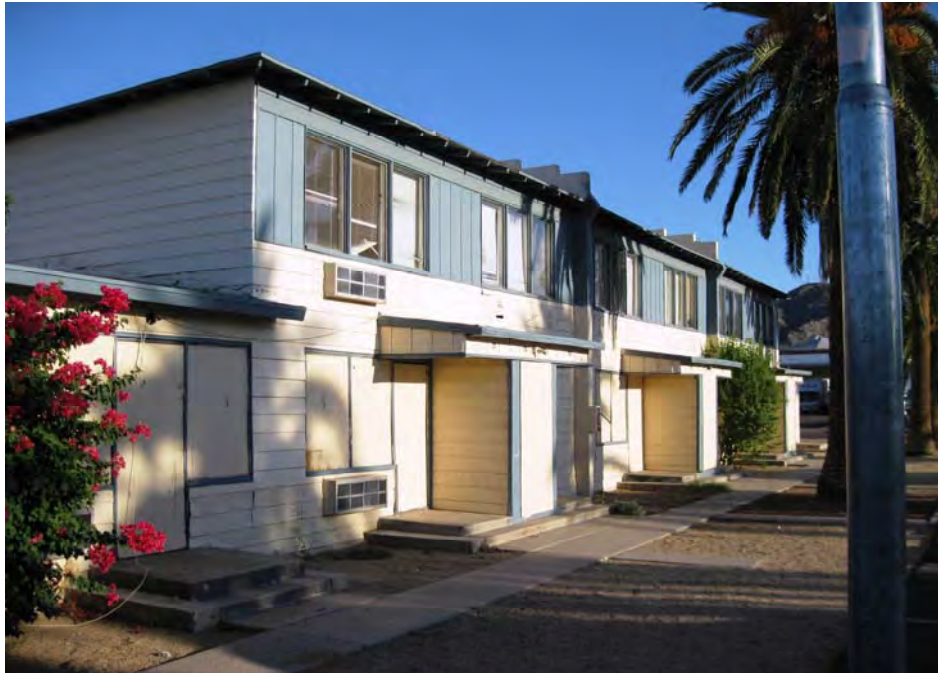
Photograph No. 4

**Description:** View of a two-story apartment building located on the west side of the Property.

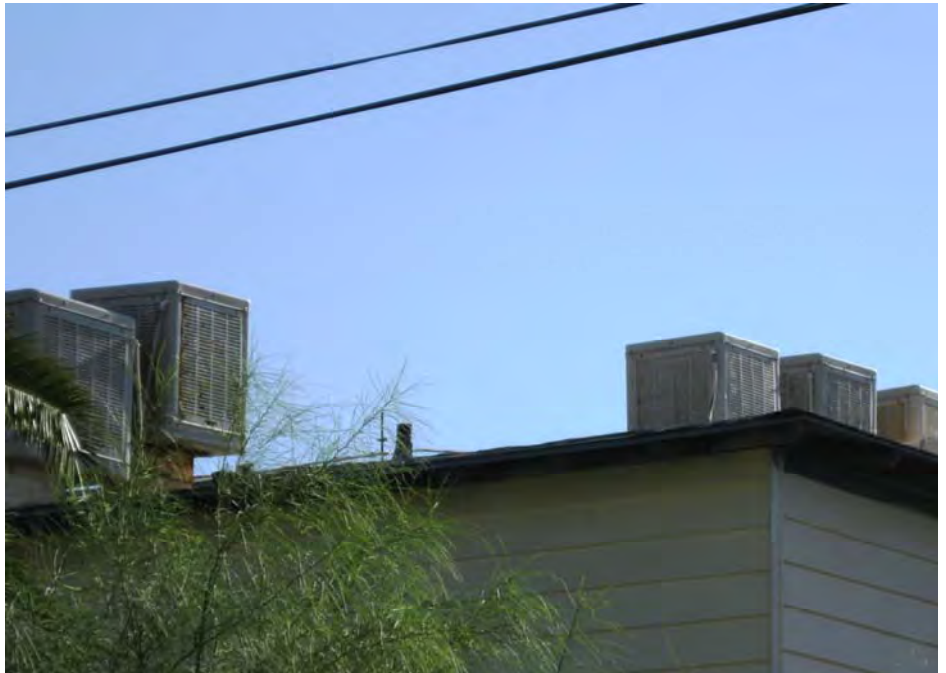
**Description:** View of evaporative coolers located on the roof of the two-story apartment buildings located on the west side of the Property.

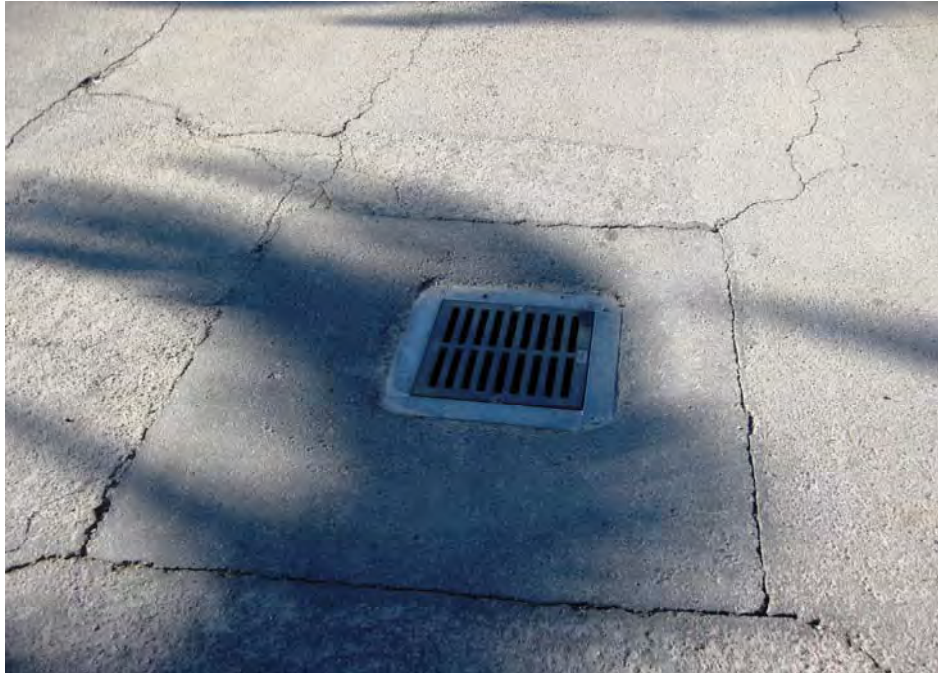
Photograph No. 8

A dry well is typically used to direct storm water into the subsurface and storm drains to offsite waterways or onsite retention areas. No dry wells were observed on the Property; however, a storm drain was observed in the center of the parking lot located near the center portion of the Property. No staining was observed in the vicinity of the storm drain. According to Ms. Vega, the drain is believed to be hooked up to the COP sewer system. No on-site retention areas were observed.

**Description:** View of the storm drain located in the parking lot near the center of the Property.

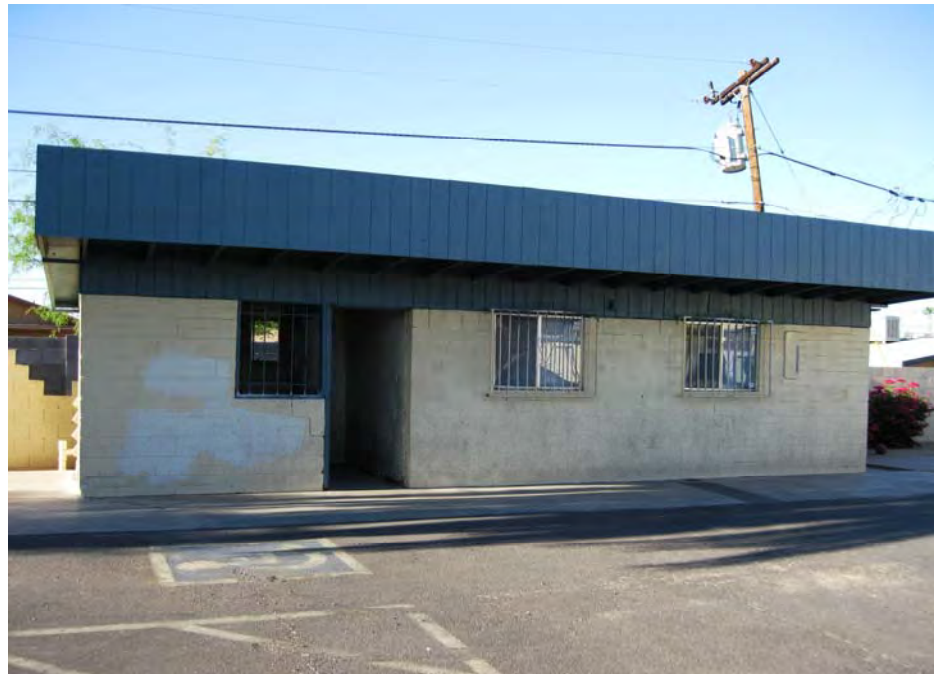
**Description:** View of the maintenance room (west side) and the previous location of a laundry room (east side – currently empty).

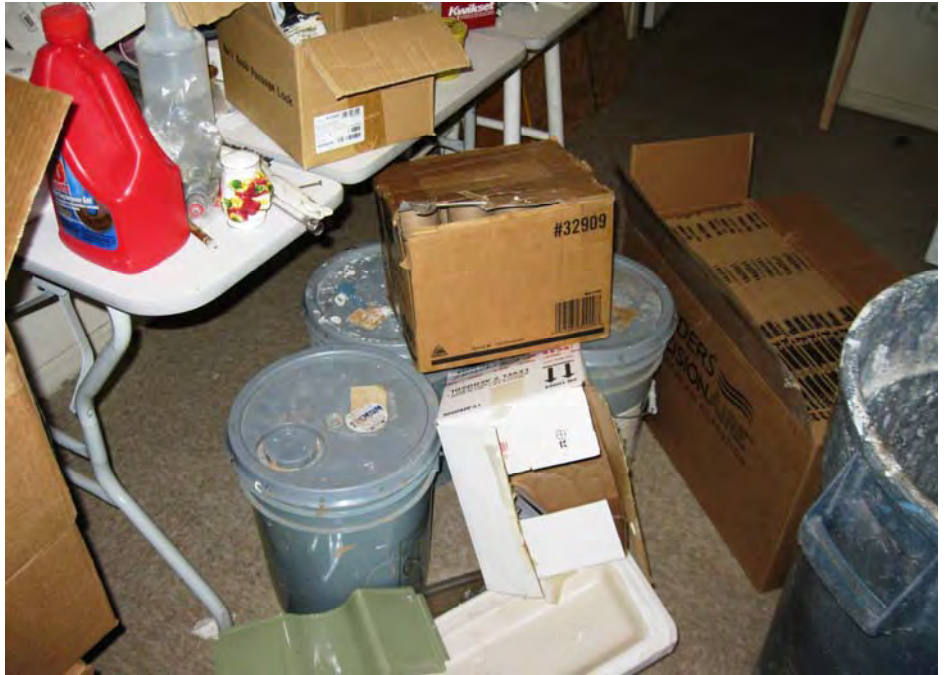
**Description:** View of maintenance supplies located within the maintenance room.

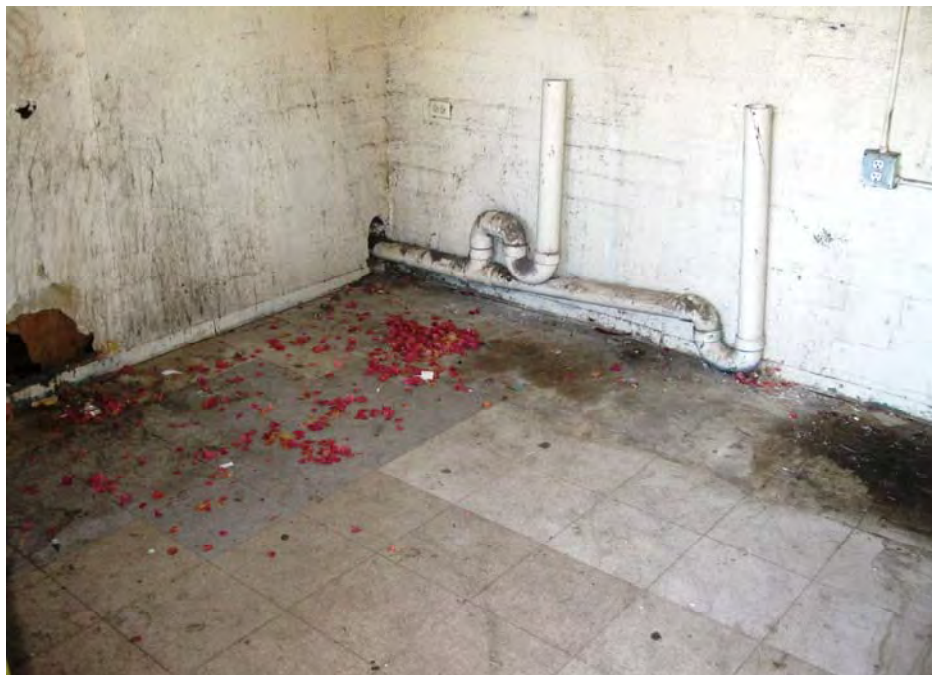
Photograph No. 10

**Description:** View of the previous location of a laundry room.

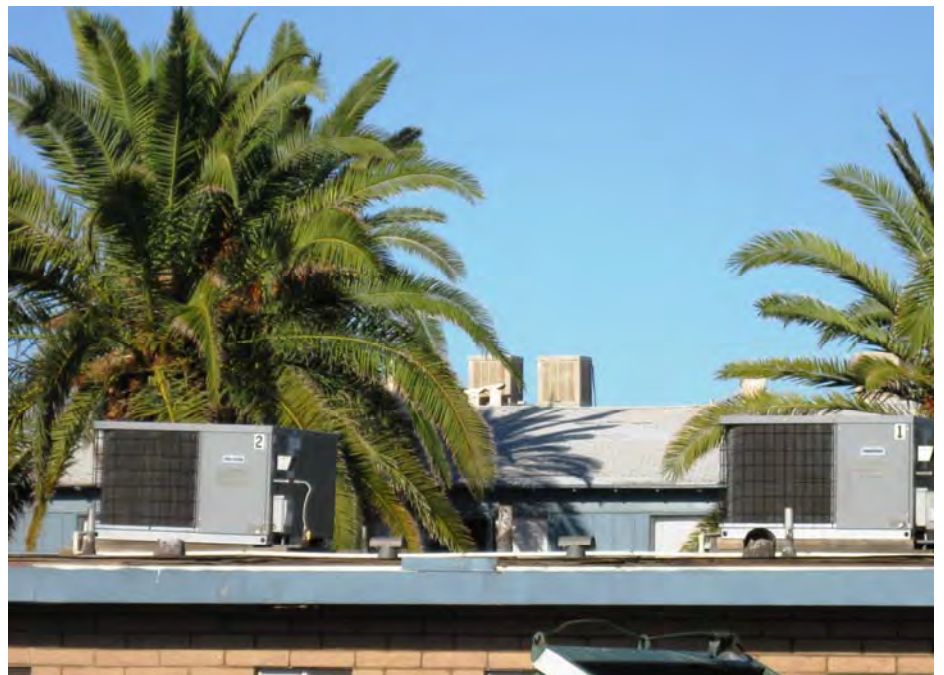
Photograph No. 12

**Description:** View of air conditioning units located on the roof of the single-story apartment buildings located on the east side of the Property.

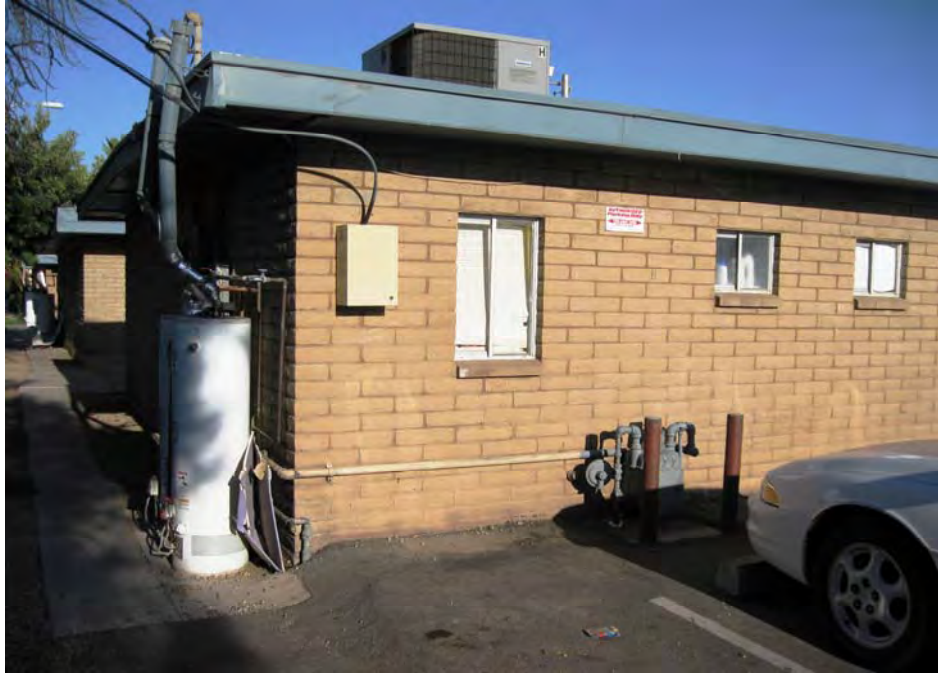
Photograph No. 14

**Description:** View of a hot water heater and natural gas meter on the southwest corner of the single-story apartment building located on the east side of the Property.

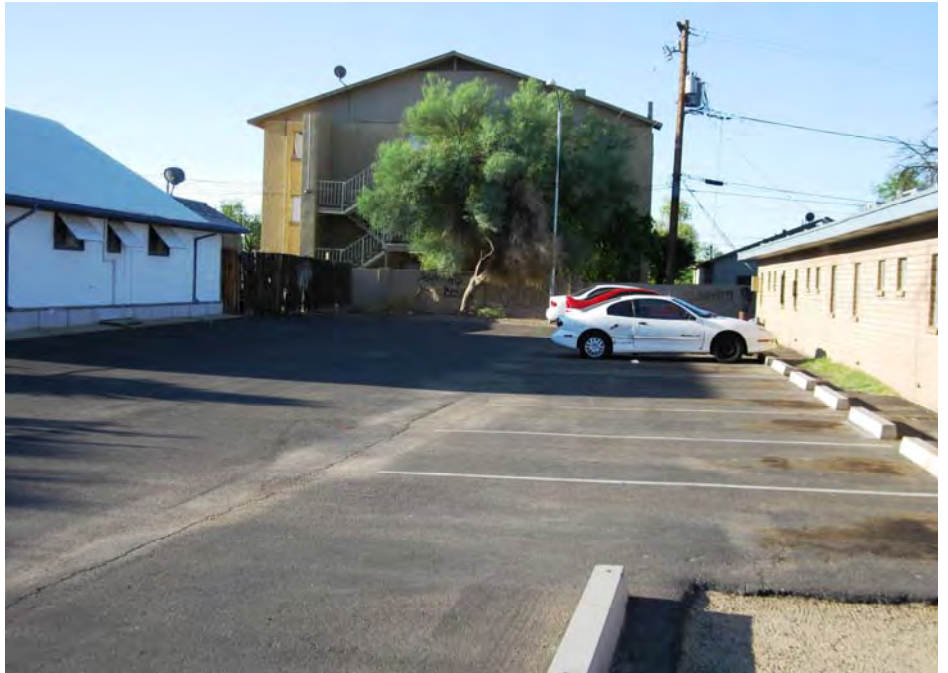
**Description:** View of the parking lot located on the east side of the Property.

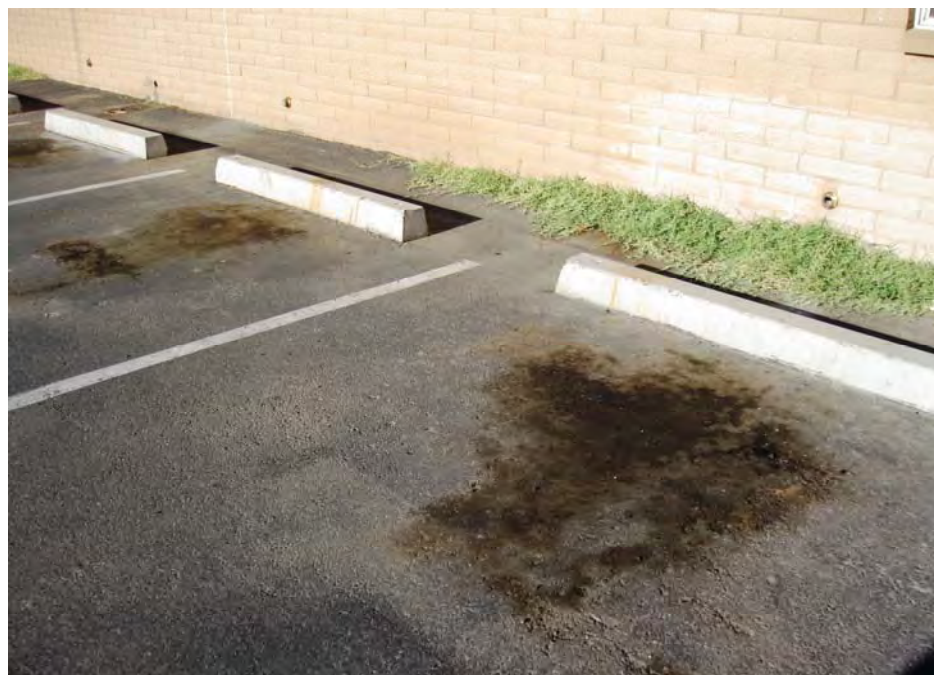
Areas of surface staining were observed on the asphalt located on the Property. The surface staining was observed in parking areas and was most likely caused by leakage from parked vehicles.

The observed staining was *de minimis* and would not be considered a recognized environmental condition.

**Description:** View of staining on the parking lot.

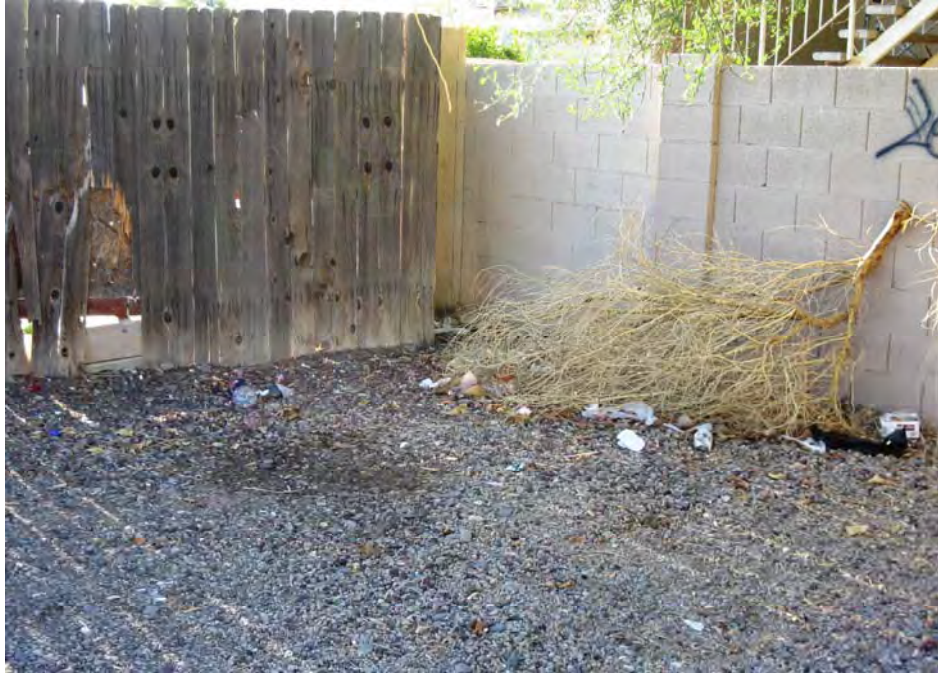
**Description:** View of trash littered on the southeast corner of the Property.

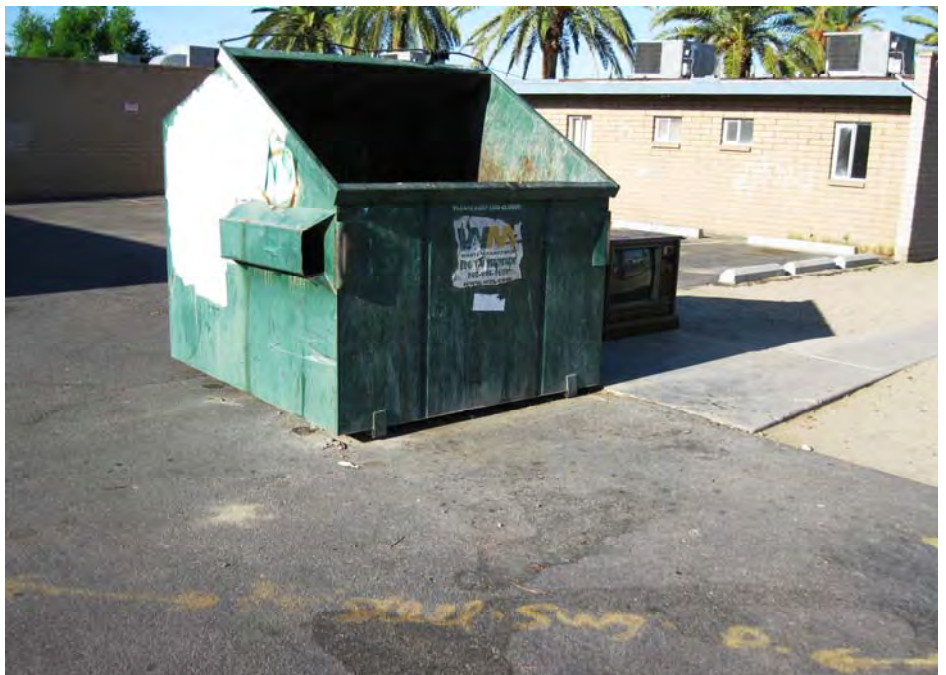
One trash dumpster was observed on the north side of the Property. Minor staining was observed on the asphalt around the dumpster. No unusual odors were observed to be associated with the staining. ITSI does not believe that the staining is petroleum or chemical related but is from typical household wastes.

**Description:** View of a trash dumpster located on the north center portion of the Property.

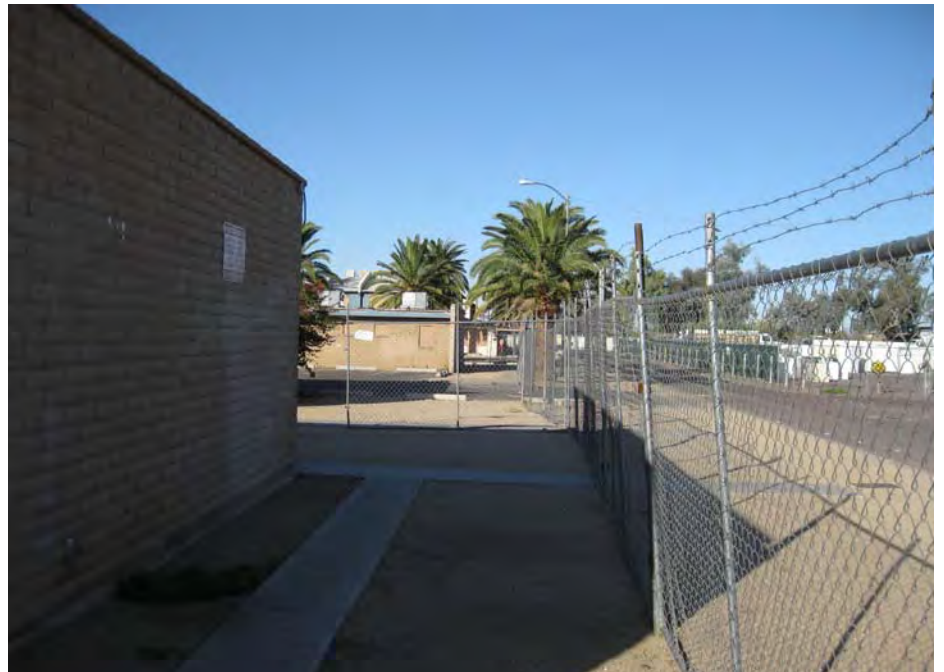
**Direction:** West

**Description:** View of the  
northern Property boundary from  
the northeast corner of the  
Property.

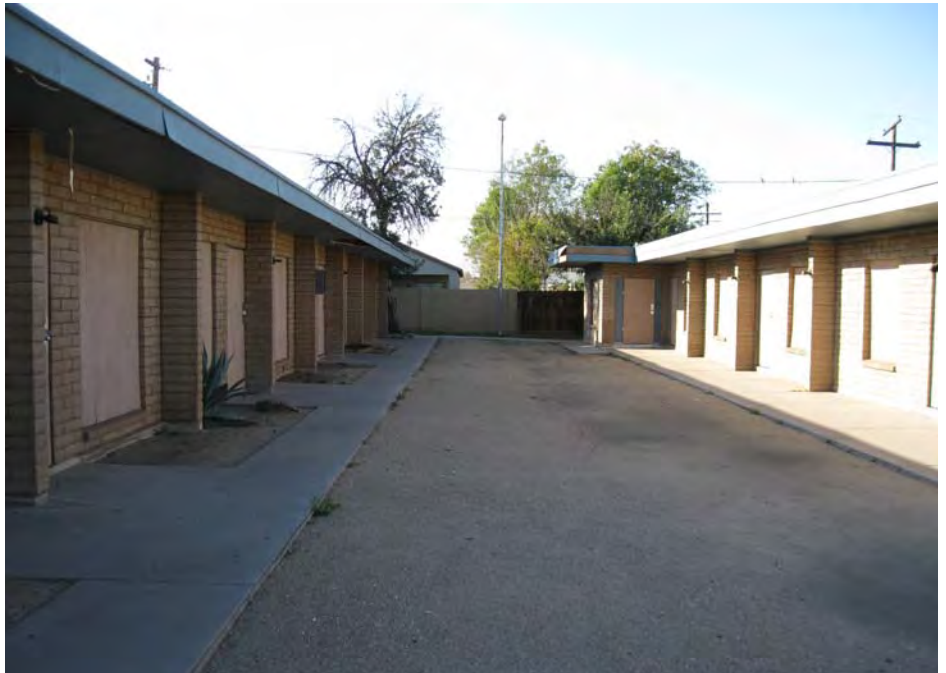
**Direction:** South

**Description:** View of the single-story apartment buildings located on the far east side of the Property.

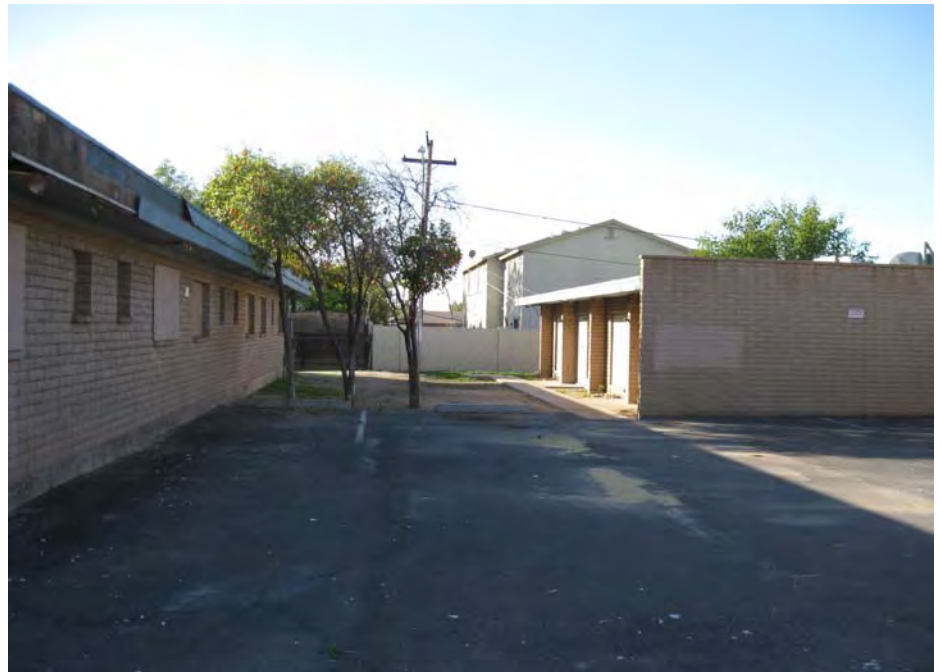
Photograph No. 4

**Direction:** South

**Description:** View of the single-story apartment buildings located on the east side of the Property, closer to the center of the Property.

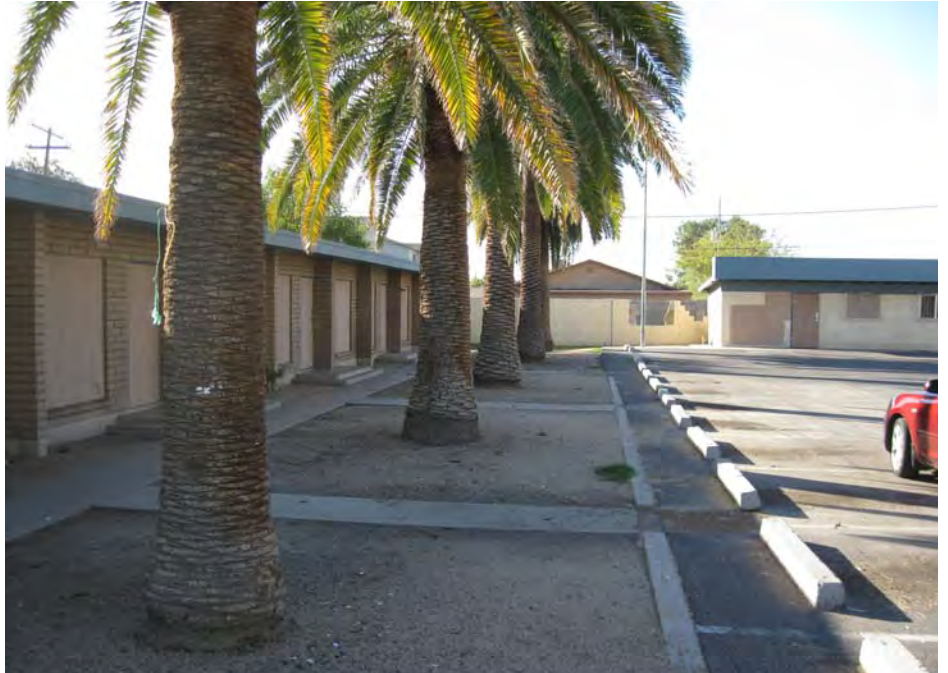
**Direction:** South

**Description:** View of the single-story apartment building and parking lot located near the center of the Property. The building on the right side is the previous laundry room.

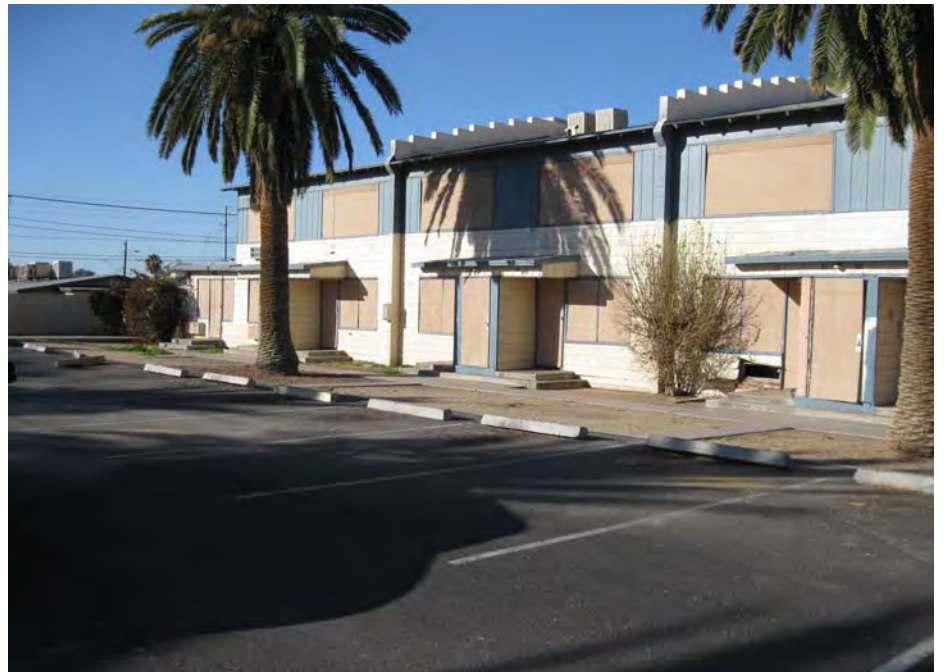
Photograph No. 6

**Direction:** Southwest

**Description:** View of the two-story apartment building and parking lot located near the center of the Property.

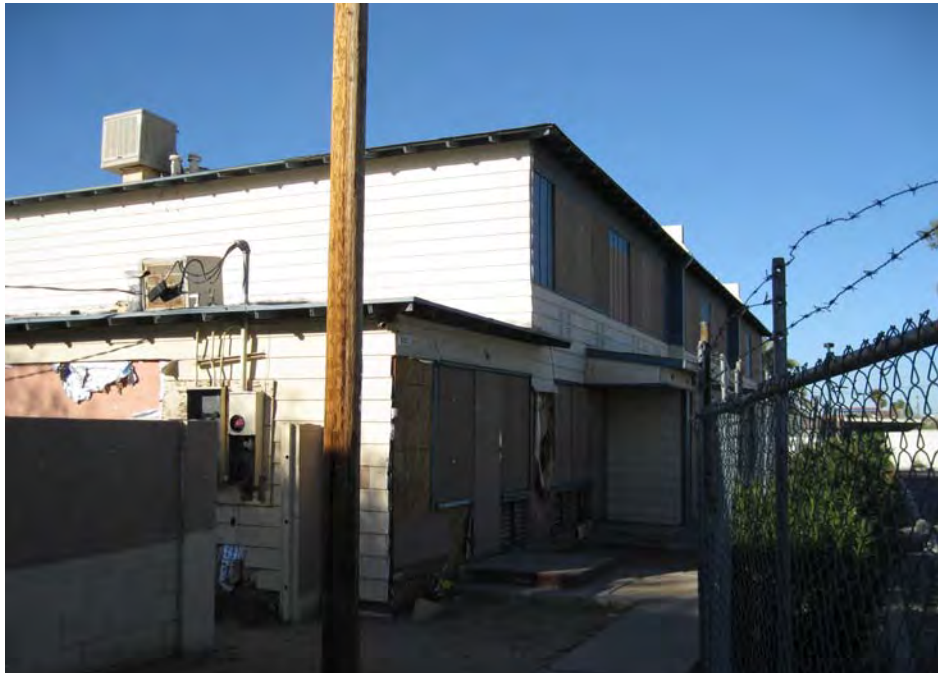
**Direction:** West

**Description:** View of a two-story apartment building located on the west side of the Property.

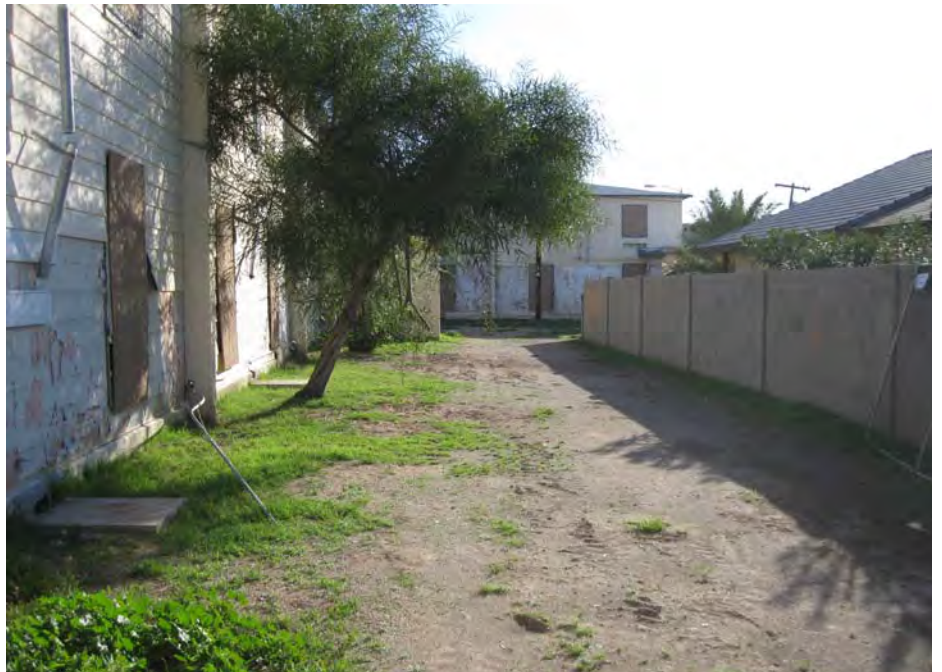
**Description:** View of the south side of the western-most two-story apartment building. During the previous assessment, tires were observed in this area.

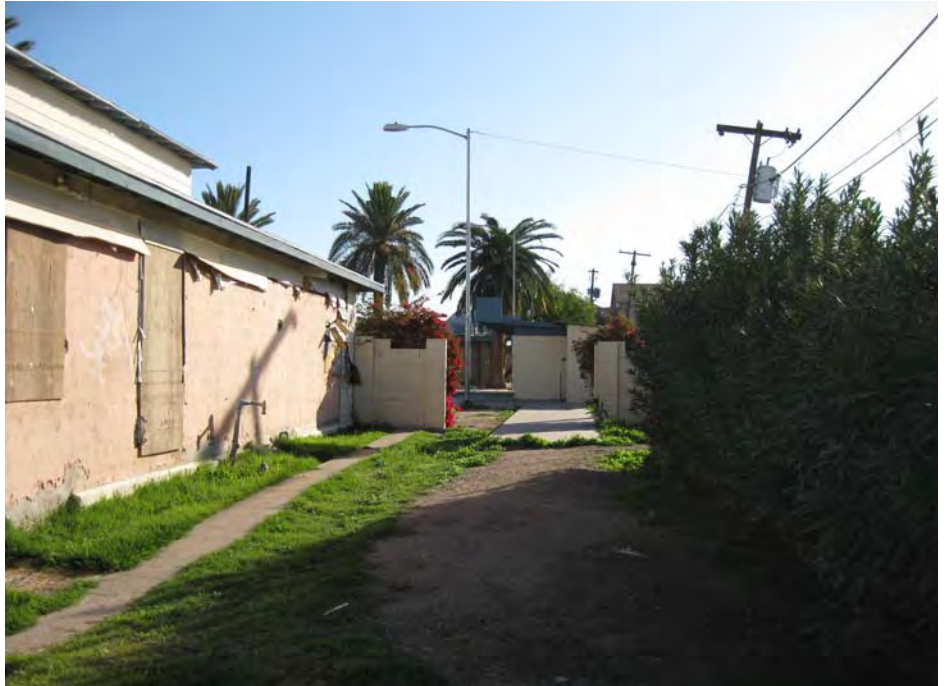
**Direction:** East

**Description:** View of the south side of the eastern-most two-story apartment building.

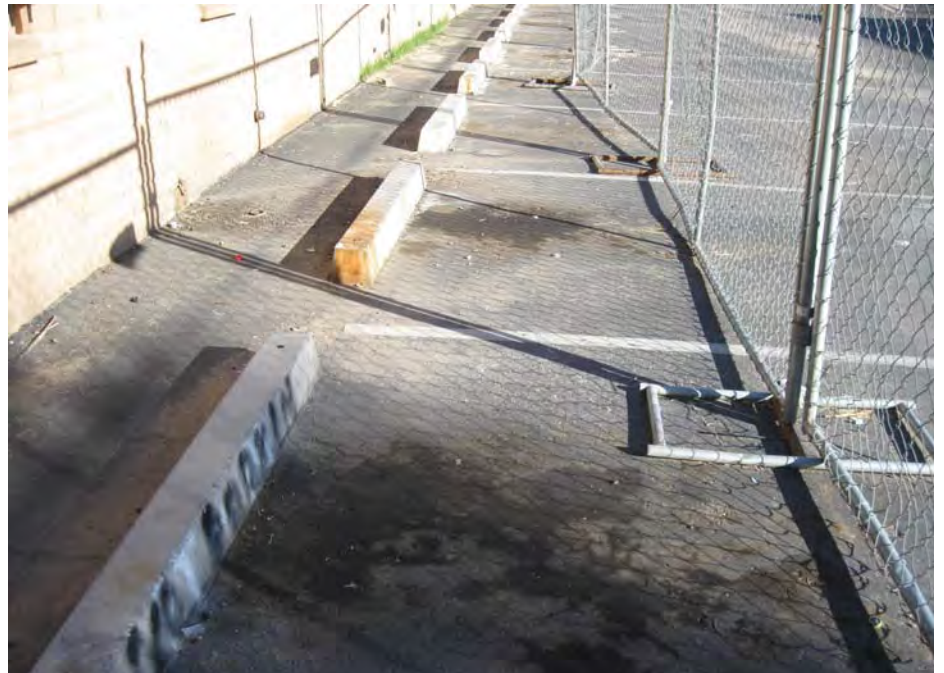
Photograph No. 10

**Description:** View of staining on the parking lot located on the east side of the Property.
