**FINAL PROJECT ASSESSMENT**  
**FOR**  
**43<sup>rd</sup> AVENUE AND CAMELBACK ROAD RR XING**

City of Phoenix Project Number: ST85100440

JUNE 2021

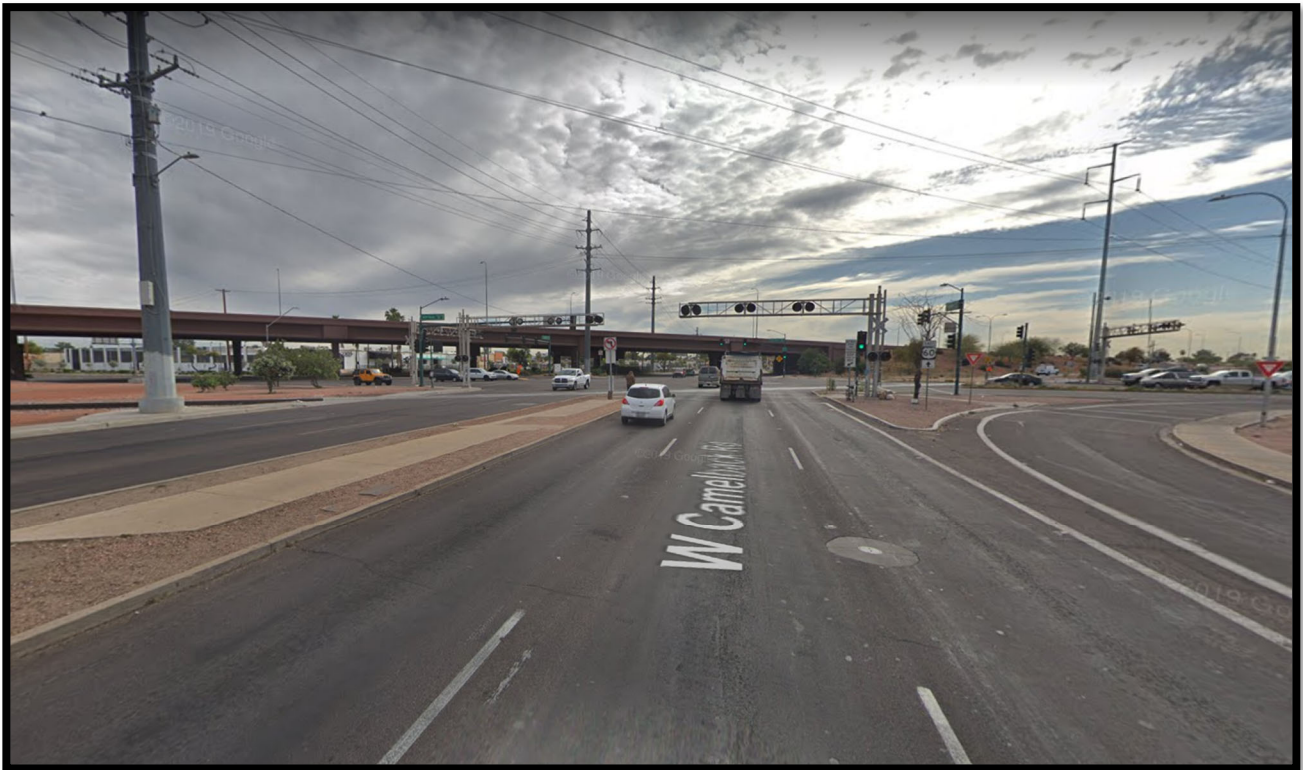
The existing roadway configuration along Camelback Road includes 3 eastbound lanes, a pork chop island for a channelized EB to SB right turn lane, 3 westbound lanes, and a dedicated WB to NB right turn lane at the intersection. Left turn movements from Camelback Road into 43<sup>rd</sup> Avenue are not allowed. This segment of Camelback Road has attached concrete sidewalk on both sides of the road and a raised median at the intersection of 43<sup>rd</sup> Avenue. This segment of Camelback Road does not include bike lanes.

The only movements that interact directly with the railroad are EB on Camelback Road and NB on 43<sup>rd</sup> Avenue. The other movements (WB on Camelback and SB on 43<sup>rd</sup> Avenue) are regulated by a traffic signal and the railroad crossing is on the other side of the roadway intersection.

Figure 2 – Camelback Road (looking east)

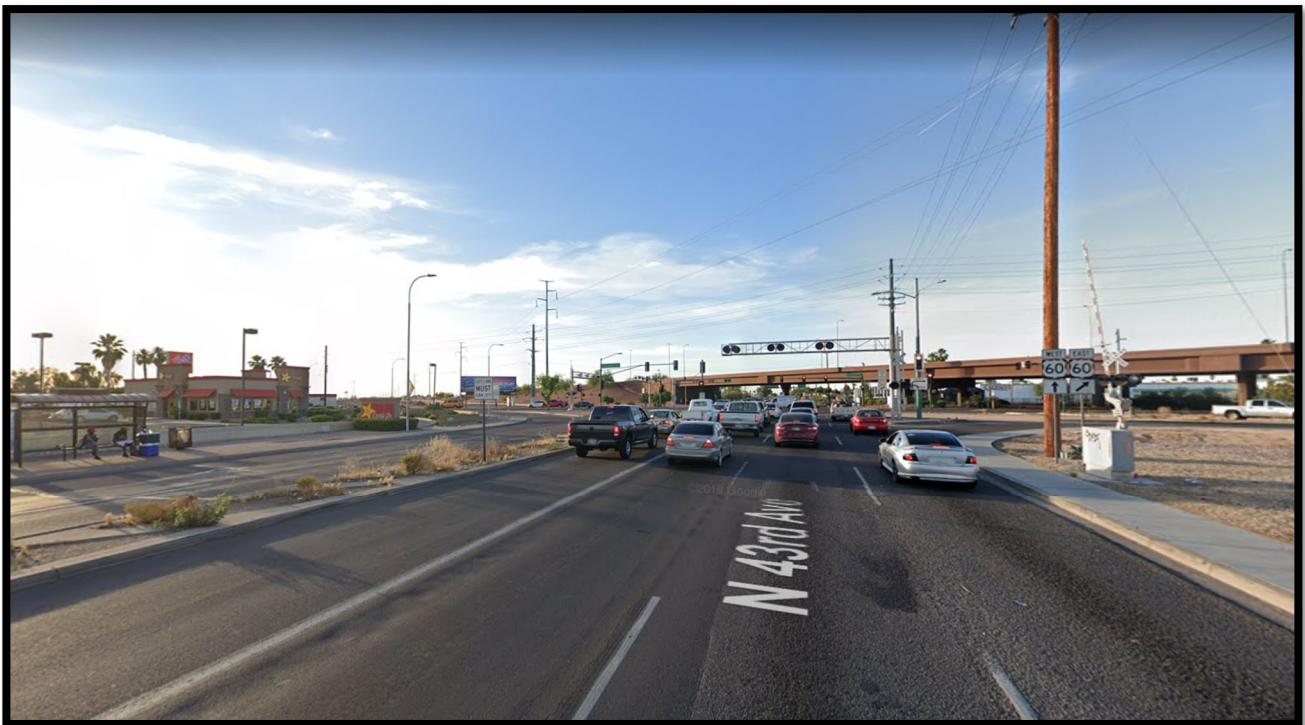
At 43<sup>rd</sup> Avenue, the existing roadway configuration is 3 northbound lanes, a pork chop island for a channelized NB to SB right turn lane into Grand Avenue (US 60), 1 NB to EB left turn lane, 3 southbound lanes, 1 SB to WB dedicated right turn lane, 1 SB to EB left turn lane, and 1 SB to SB into Grand Avenue (US 60) left turn lane. This segment of 43<sup>rd</sup> Avenue has attached concrete sidewalk on both sides of the road and a raised median at the intersection of Camelback Road. This segment of 43<sup>rd</sup> Avenue does not include bike lanes. Only the NB movement can conflict with a crossing train without drivers from that movement running a red light and breaking the law. In order to avoid setting an expensive and unnecessary precedent, only the NB lanes will be focused for improvement. In order to avoid confusion for drivers making a SB to WB right turn on red, a signal and gate will also be placed to block with movement.

Figure 3 – 43<sup>rd</sup> Avenue (looking north)

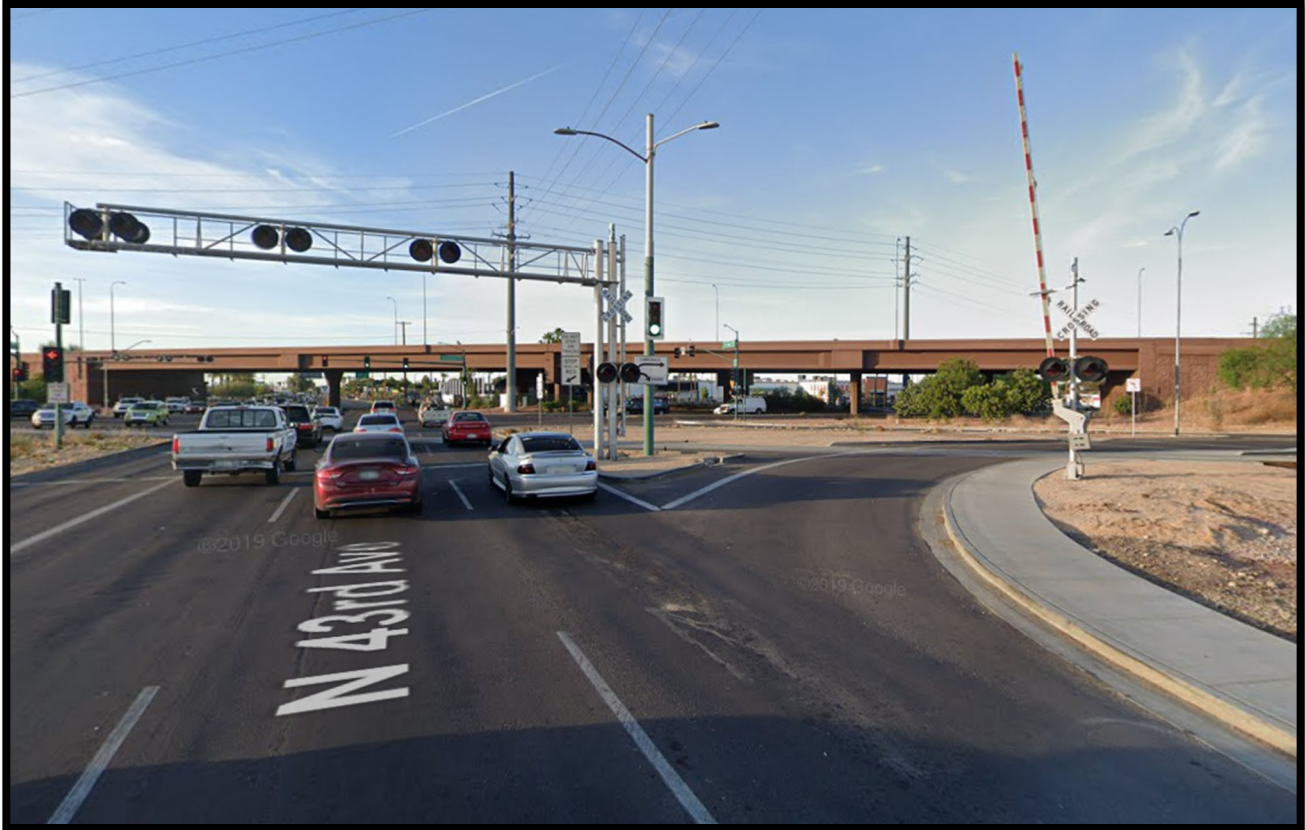
The existing BNSF railroad crossing includes cantilevers in all directions (north, south, east, and westbound). The northbound right turn lane does have a gate arm installed only for that movement.

Figure 9 – Railroad Warning Devices at 43<sup>rd</sup> Avenue (looking north)

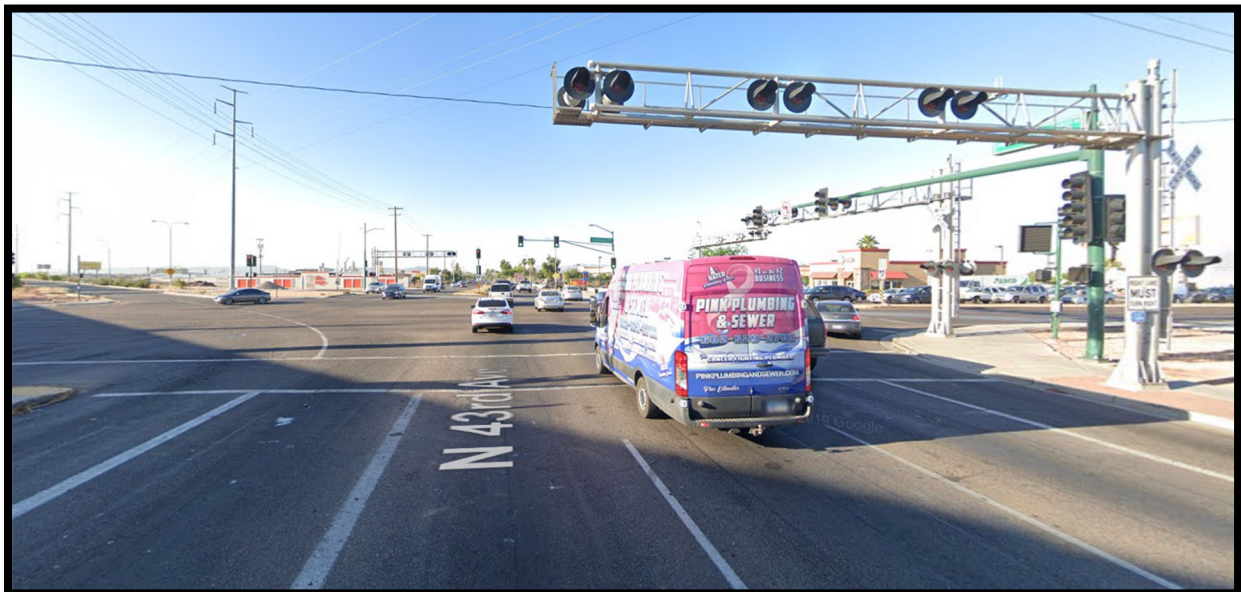
Figure 10 – Railroad Warning Devices at 43<sup>rd</sup> Avenue (looking south)

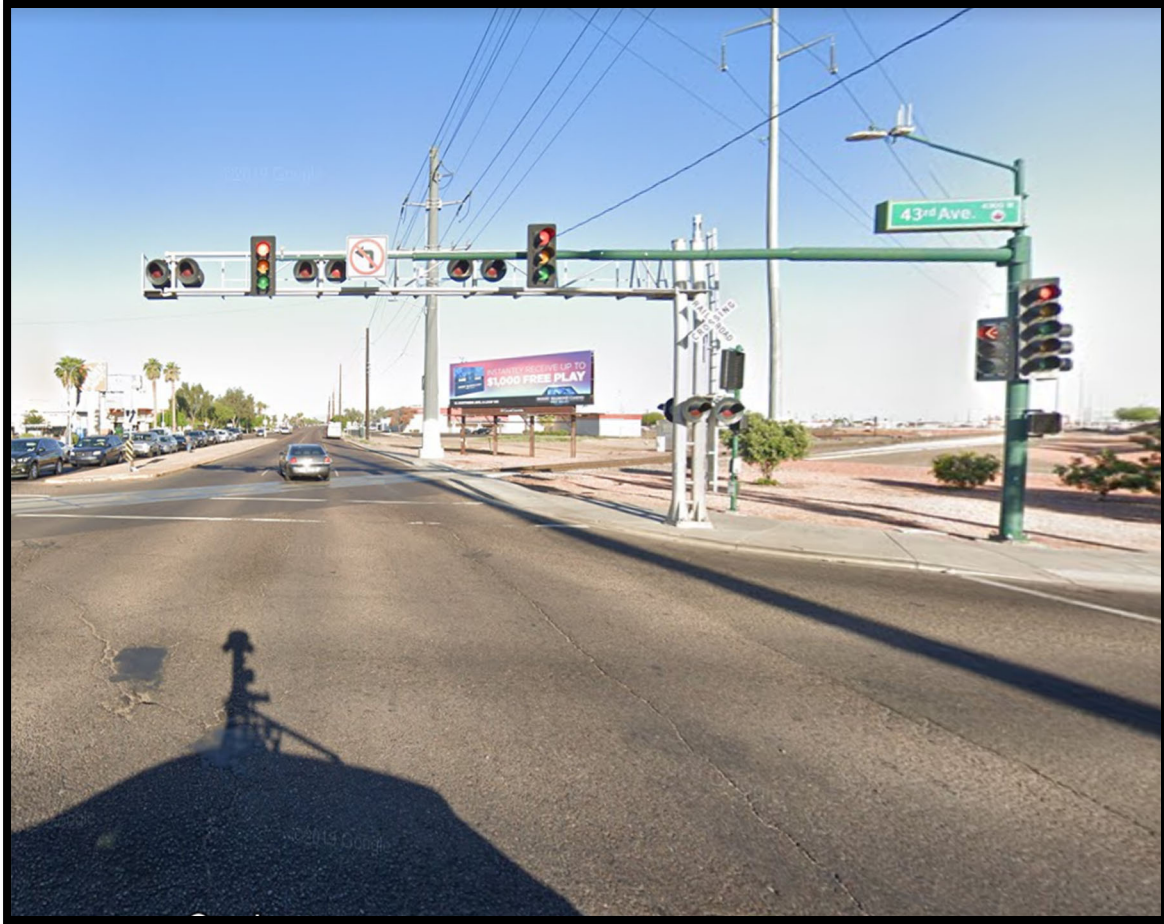
Figure 11 – Railroad Warning Devices at Camelback Road (looking west)

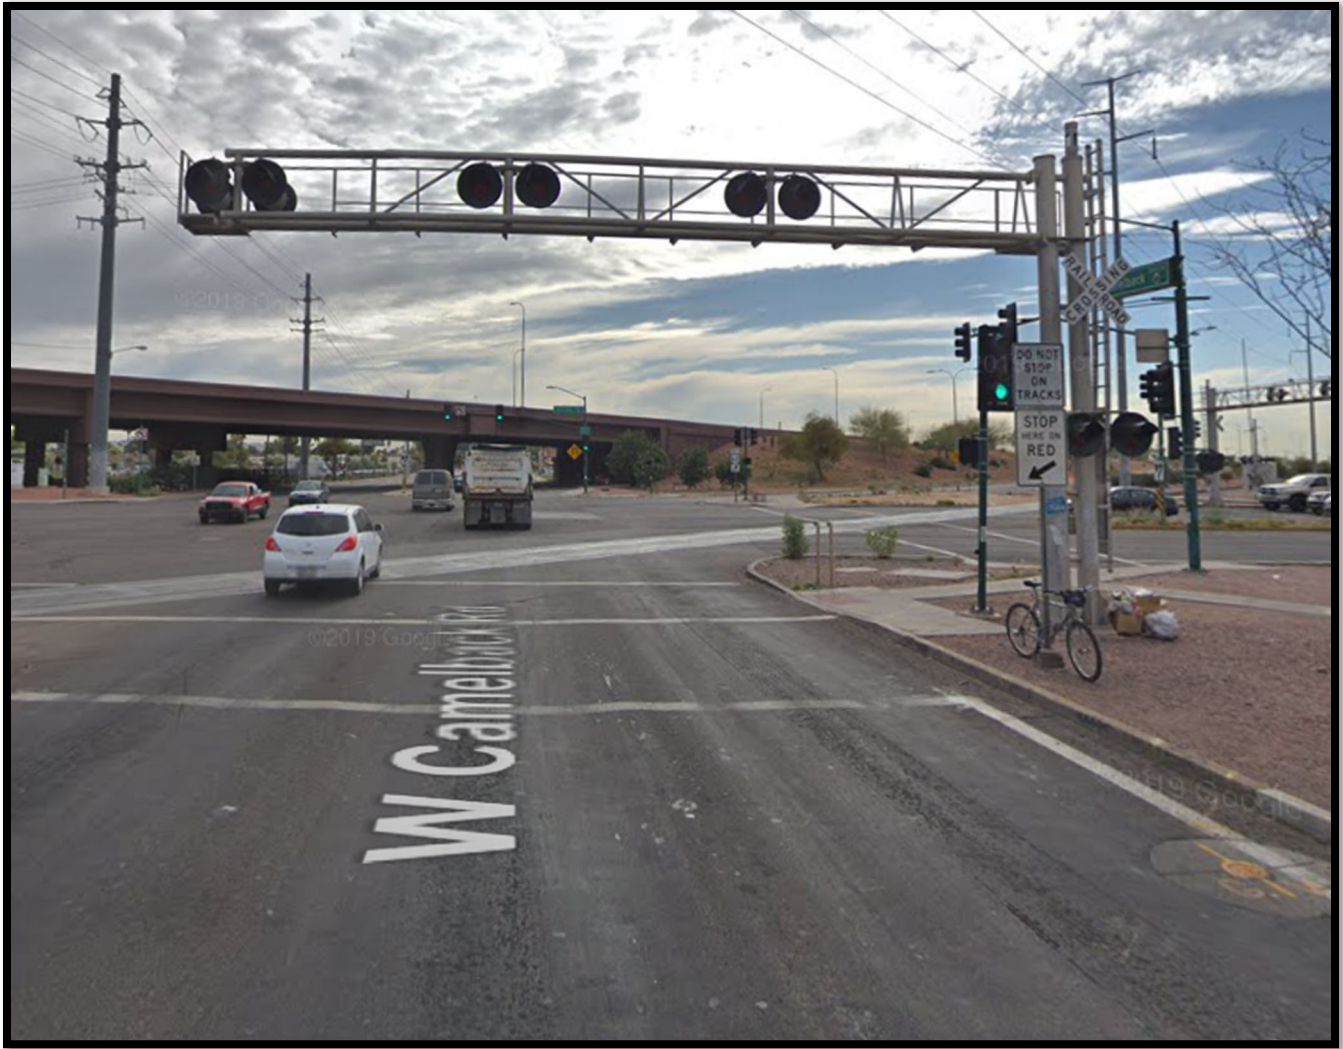
Figure 12 – Railroad Warning Devices at Camelback Road (looking east)

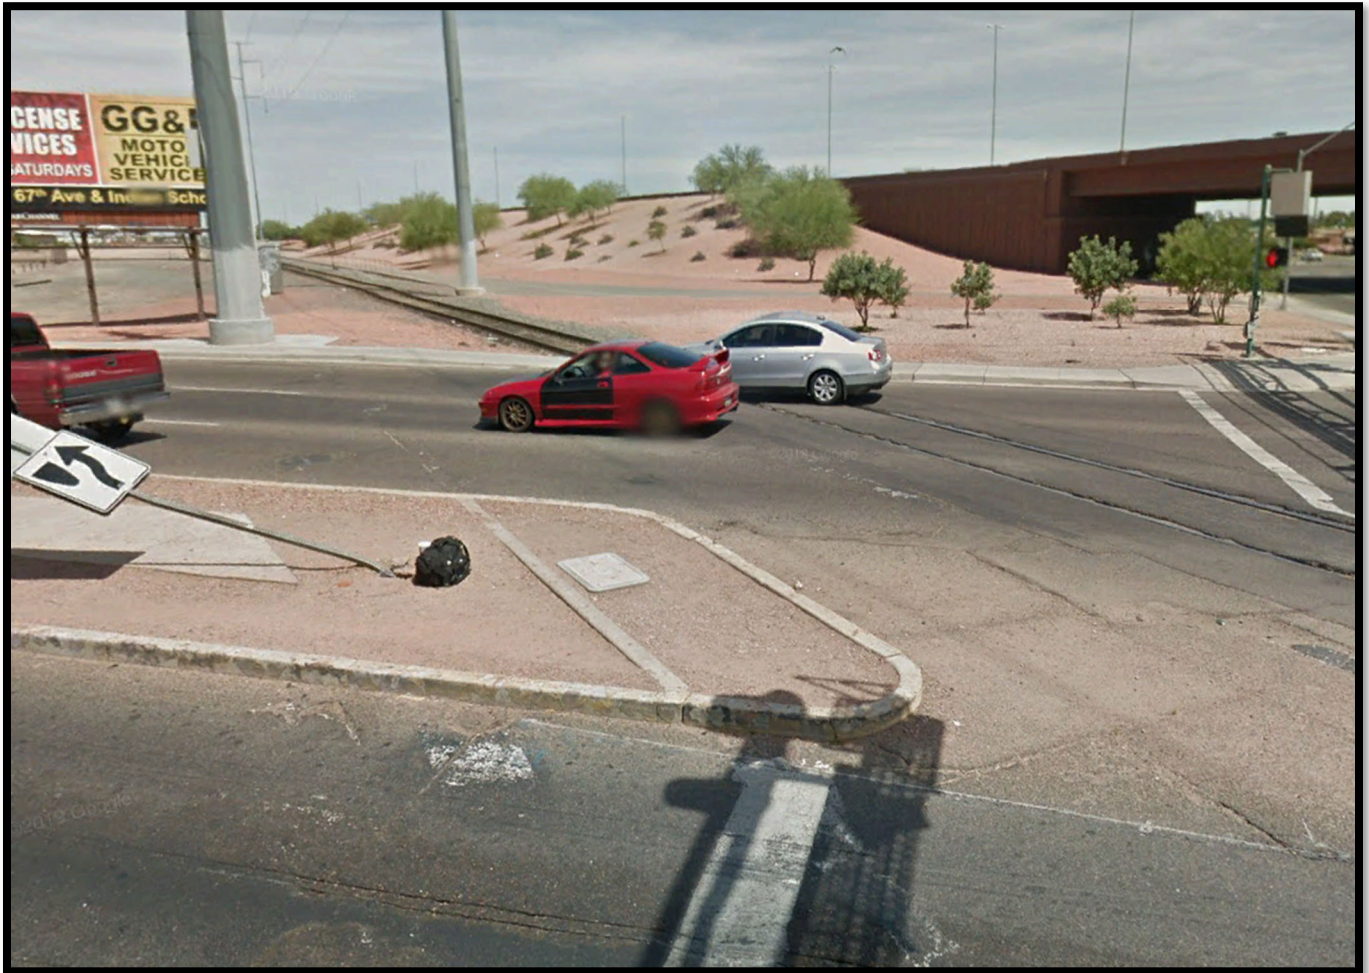
Based on the information received from utility companies, it appears that the new gate arms at the raised median may be in conflict with existing Zayo facilities (2-1.25" HDPE conduits) and City of Phoenix traffic signal conduit. There is an existing traffic signal pull box in the median that will likely need to be relocated (see picture below).

Figure 16 – Existing Traffic Signal Pull box
